CAMERON BALLOONS LTD

SERVICE BULLETIN: SB11

Subject: **A-type Envelopes**

Title: **Inspection of 'Lens' panel to 'Top' panel seam.**

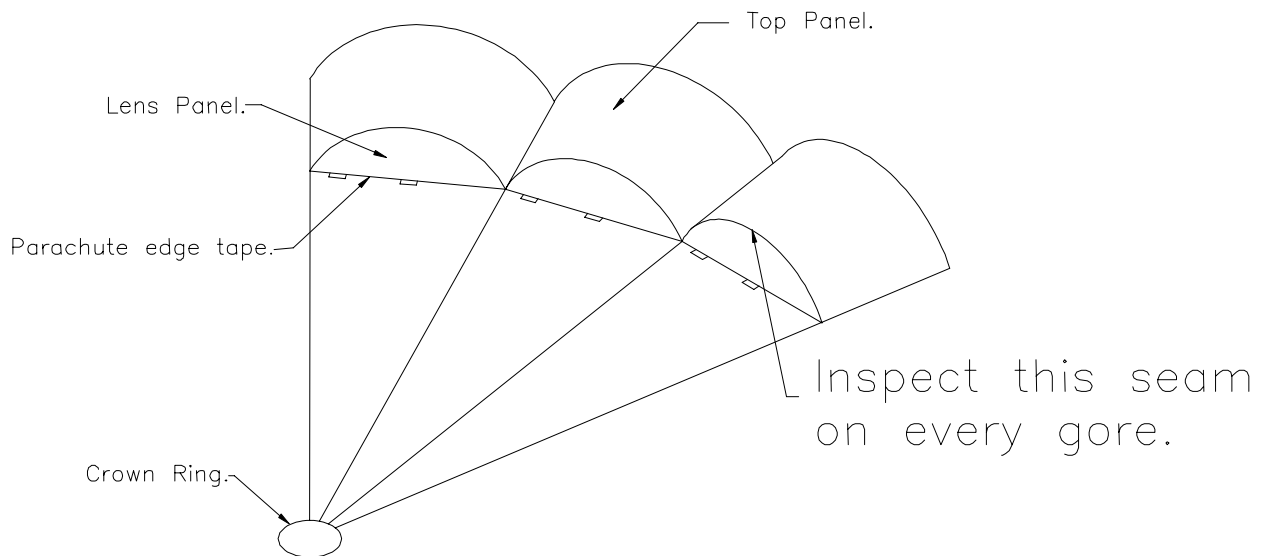
Reason for Modification: **Possible unpicking of envelope seam through contact with Parachute Velcro tabs.**

Unpack the balloon and locate the Crown Ring. Then carefully inspect the inside and outside of the seam indicated below for signs of unpicking.

2. If less than 2” (50mm) of damaged stitching is evident, this is acceptable until the next scheduled inspection, when any damaged stitching must be repaired in accordance with Section B of this Service Bulletin, or Amendment 2 of the Cameron Balloons Maintenance Manual Issue 9 and any subsequent revisions.

3. The seam must be repaired before further flight if any of the following apply

- a) Both rows of stitching completely broken.
- b) More than 2" (50mm) of either row of stitching completely broken.
- c) Two or more sections of damage between vertical load tapes, where each section has less than 2" (50mm) of either row of stitching completely broken.
